# MAX9295D DEV\_REV=8 (D-0C) ERRATA SHEET

Corresponds to data sheet 19-100518; Rev6; 11/23

## DEV\_REV=8 (per reading register 0xE)

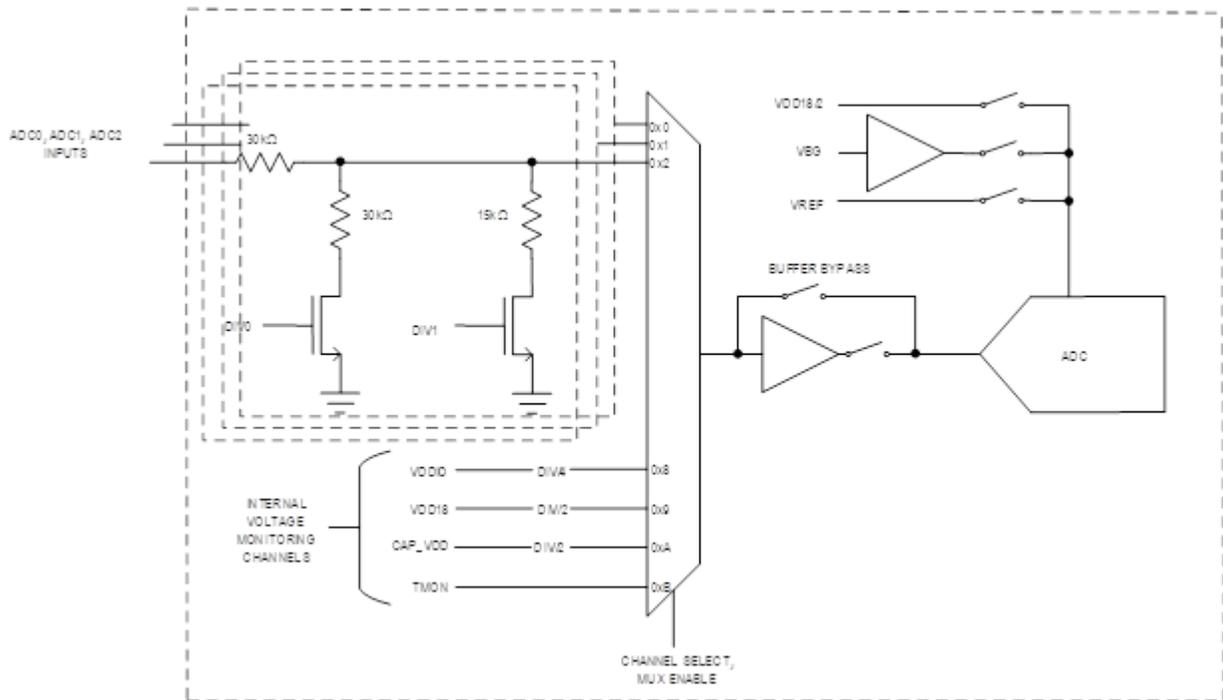
### 16) ADC input Multiplexer is incorrectly documented in data sheet

**Description:**

Input 0xA of the ADC input multiplexer (register 0x501, bits [7..4]) should be described as CAP\_VDD, not VDD in data sheet figure 32. The ADC input multiplexer is incorrectly documented in data sheet

**Workaround:**

Use register definition is update in table below.

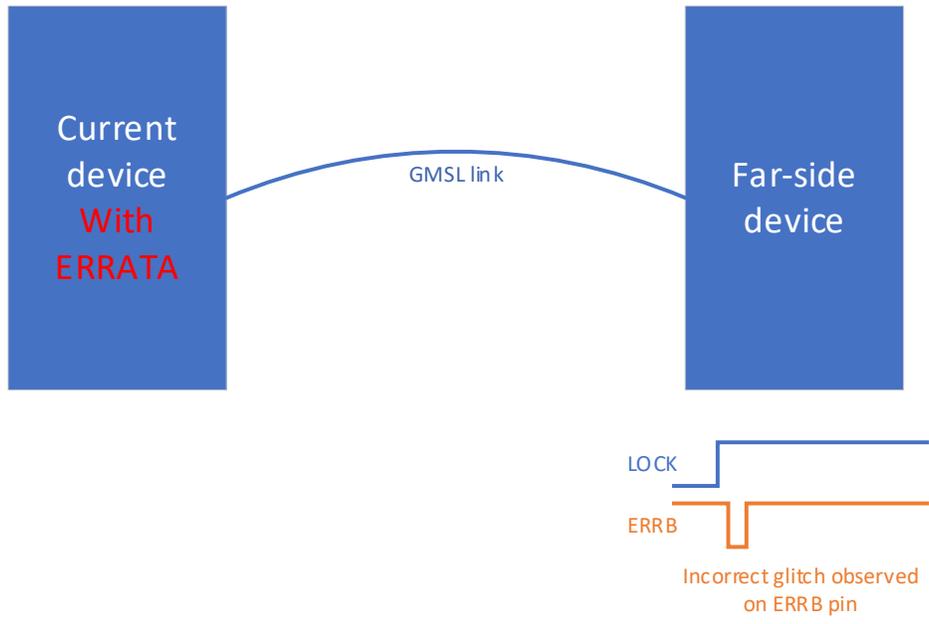
**17) ADC registers incorrectly documented in data sheet**

**Description:**

If REM\_ERR\_OEN is enabled on far-side device before link lock, there will be a ~1us glitch on far-side ERRB upon link lock if there are no errors on both sides of the link.

**Workaround:**

Enable REM\_ERR\_OEN on far-side device only after link lock. If REM\_ERR\_OEN on far-side device is 1 before link lock:

If SOC is on far-side device:

1. Disable ERR\_RX\_EN local before link lock
2. Wait for link lock
3. Disable ERR\_TX\_EN remote
4. Enable ERR\_RX\_EN local
5. Enable ERR\_TX\_EN remote

If SOC is on current device:

Disable ERR\_TX\_EN local before link is down  
Wait for link lock

1. Disable ERR\_RX\_EN remote
2. Enable ERR\_TX\_EN local
3. Enable ERR\_RX\_EN remote
4. Disable ERR\_TX\_EN local
5. Enable ERR\_TX\_EN local
